Investigation report

B 2/2003 L

Aircraft accident at Enontekiö on June 25, 2003

Cessna A185F

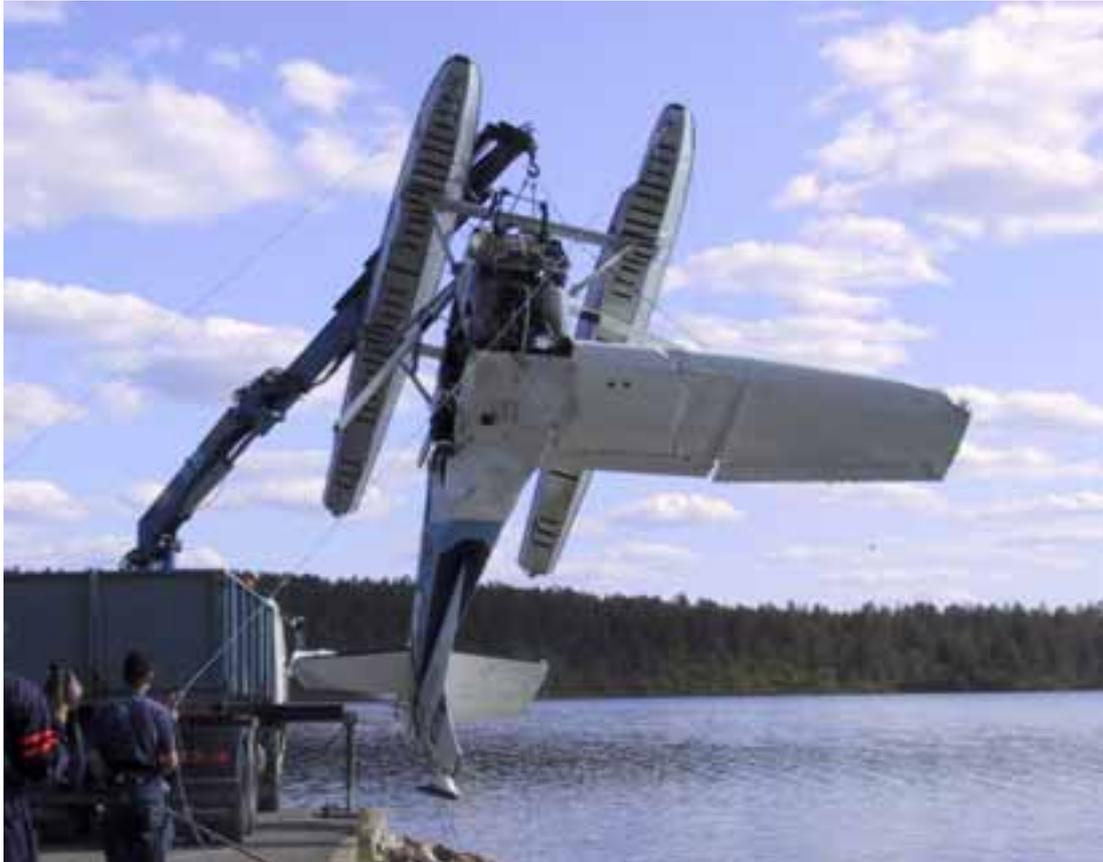
The right wing was in its original shape. Only the right wing tip leading edge was dented and the tip was missing. The flap was extended 20°. The left wing was torn off from its attaching points and was bent all along. The wing came loose while the wreckage was lifted on ground. The flap was torn off and aileron was broken in two in the middle where the moving mechanism was attached. The fuselage was bent behind the cabin. Left ele-

vator was damaged and the rivets of the torque tube were broken. Left side of the tail cone was dented. The upper part of the rudder was damaged and bent downwards. All four engine mounting points were broken and engine was loose. It broke off completely when the aircraft was lifted on ground. Left side of the engine oil reservoir was broken open and there were markings from an engine mounting point. The engine cover sheets were still attached to the engine.

Figure 1. The aircraft sustained extensive damage when hitting the water surface.

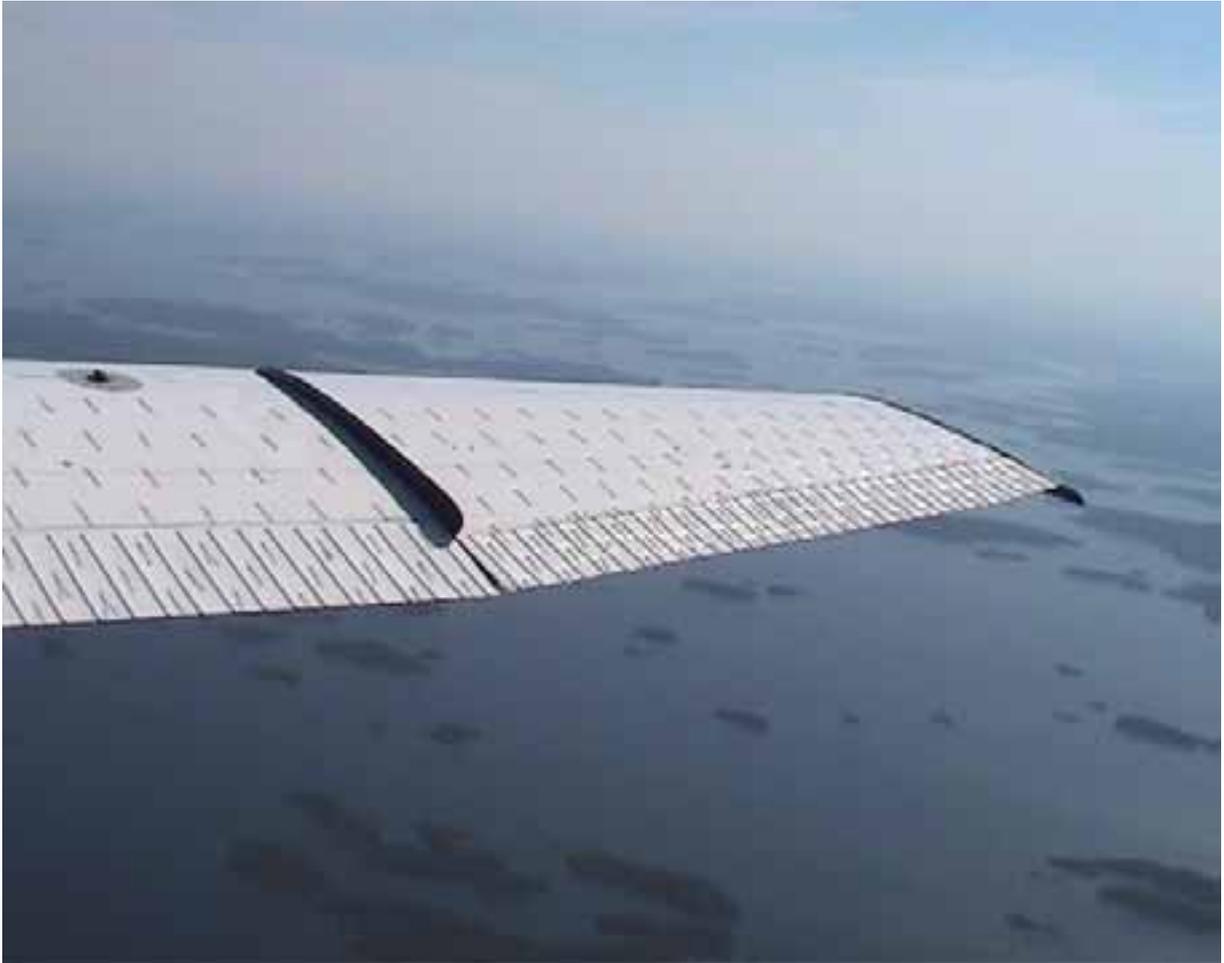
Figure 7. Right wing with flaps up and aileron neutral. The flow is attached to the wing upper surface.

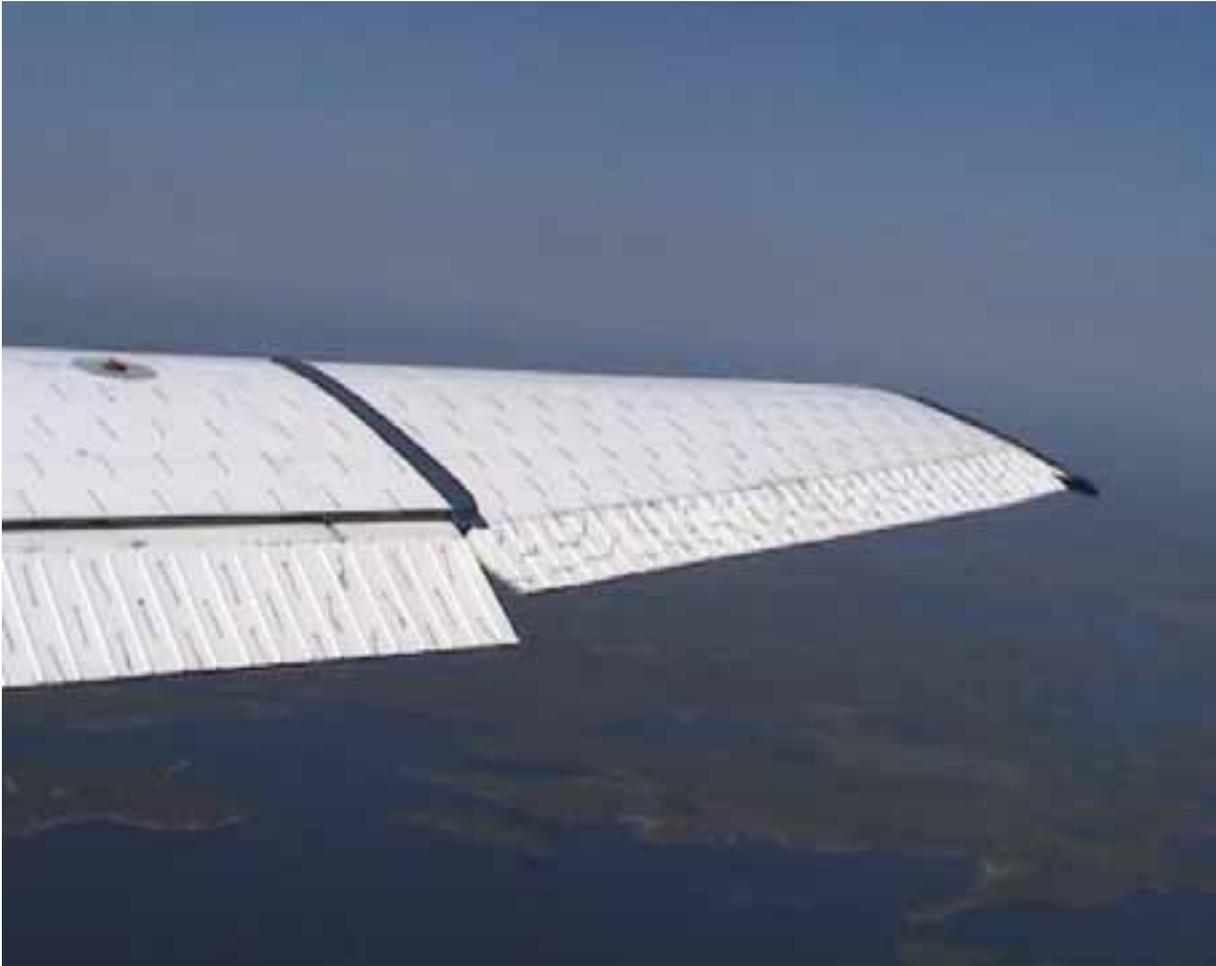
With the aileron at an angle of 13 degrees and air speed of 80 knots or less, the flow separated from most part of the aileron (figures 7 and 8). The phenomenon was not investigated at faster air speeds.

Figure 8. Flap in take off position (20°), when the aileron is at a 13° angle, air speed 80 kt. The flow separation can be seen from the wool threads.

Because the flow is separated from the upper aileron surface with the aileron at an angle of 13 degrees with speeds up to 80 knots, the aileron control effectiveness is reduced when compared to the clean configuration with flow attached to the whole surface. The flow separation from the upper aileron surface was evident also in the aerodynamic calculations.

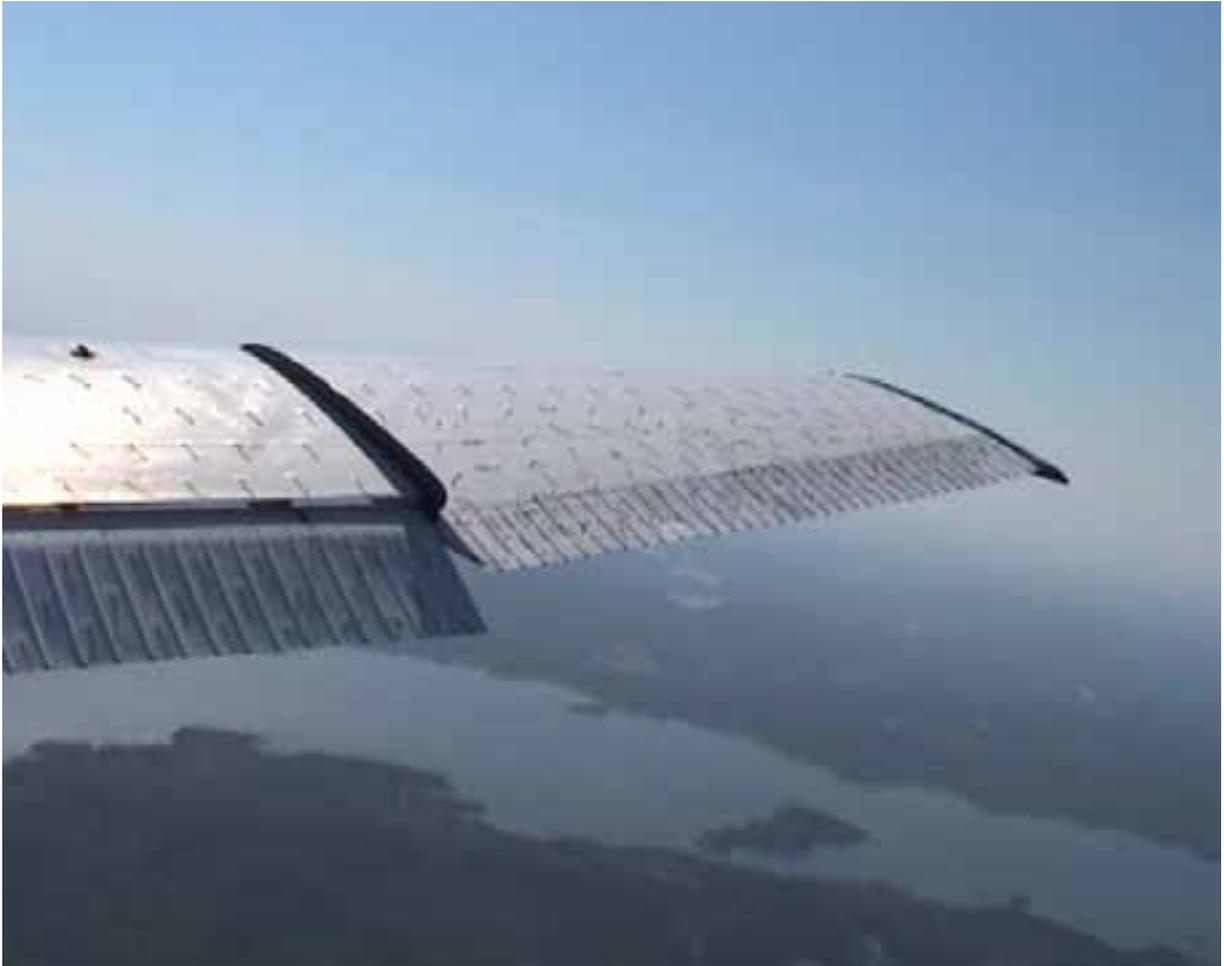
It was possible to suddenly stall the aircraft at a speed of 50-55 knots in the take off configuration causing right roll and pitch down. This was caused by the sudden right wing tip stall. A safe stalling behaviour is such that the flow separation starts from the wing root trailing edge and progresses slowly towards to leading edge and wing tip when the angle of attack is increased.

The cause of the right wing tip stall was the aileron angle of 13 degrees. The aileron angle is unfavourable especially in the aileron system utilized by Cessna and having a hinge on the upper surface. Thus aileron angle causes a sharp edge to form on the upper surface. The air is unable to flow around such a sharp edge and stay attached.

Figure 9. Airflow separation from the right wing tip when stall begins.

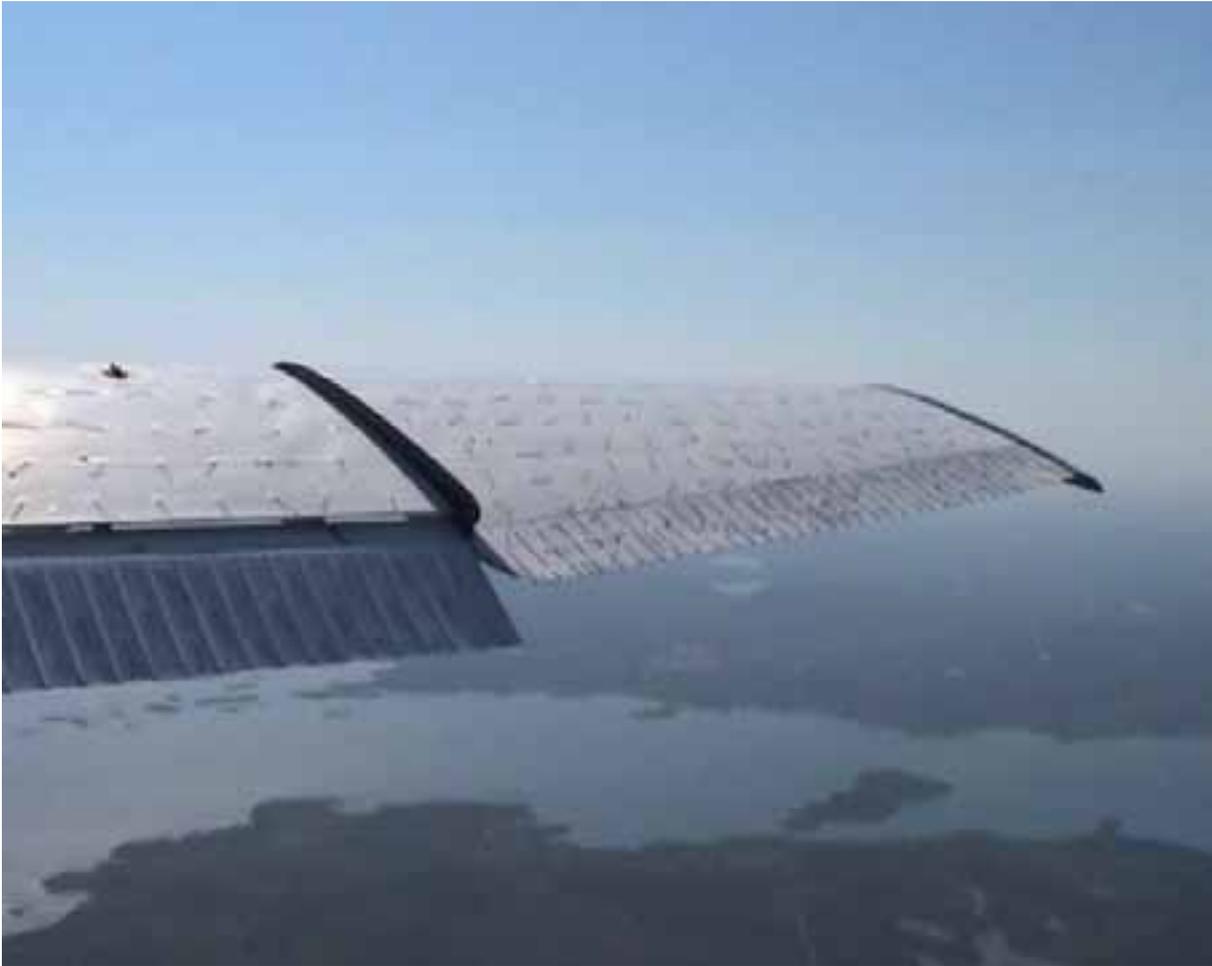
The asymmetric propeller wash caused the aircraft right wing to stall first. The fact that the sudden roll to the right requires the complete right wing to suddenly stall corresponds well to the aerofoil and flight mechanical calculation results.

Figure 10. Airflow separation from the whole right wing during a complete stall.
