Investigation report

B 2/2003 L

Aircraft accident at Enontekiö on June 25, 2003

Cessna A185F

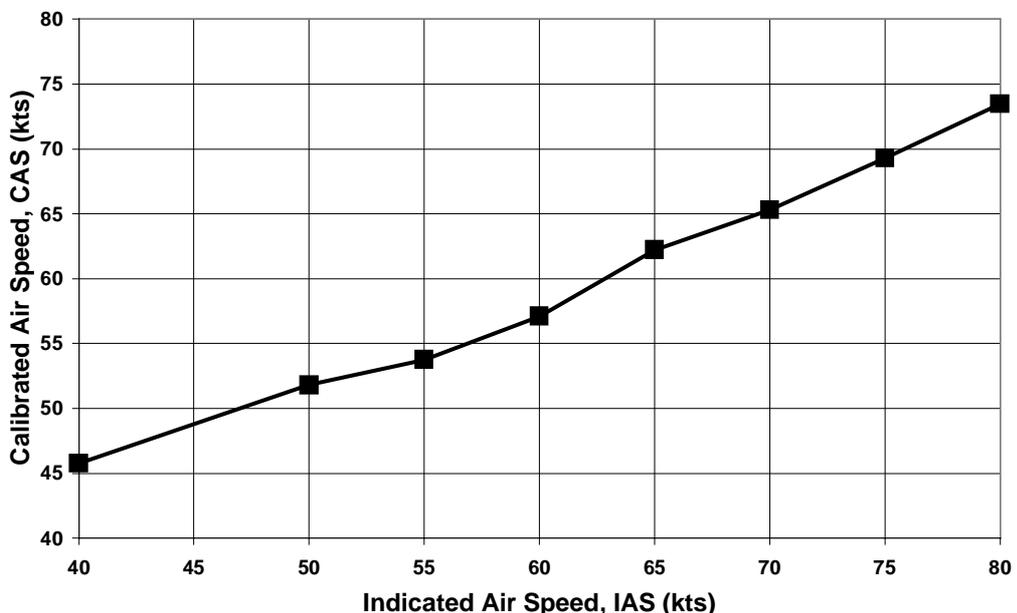
On 9 September 2004, a test flight was flown to check the air speed indicator of OH-CDO. The indicated air speed was compared to GPS ground speed. The flight was flown in opposite directions so that the wind could be calculated. The resulting true air speed was reduced to sea level using international standard atmosphere. This speed was called equivalent air speed, and can be considered calibrated air speed as well. Figure 2 presents the calibrated air speed as a function of the indicated air speed.

Figure 2. Calibrated air speed of OH-CDO as a function of indicated air speed

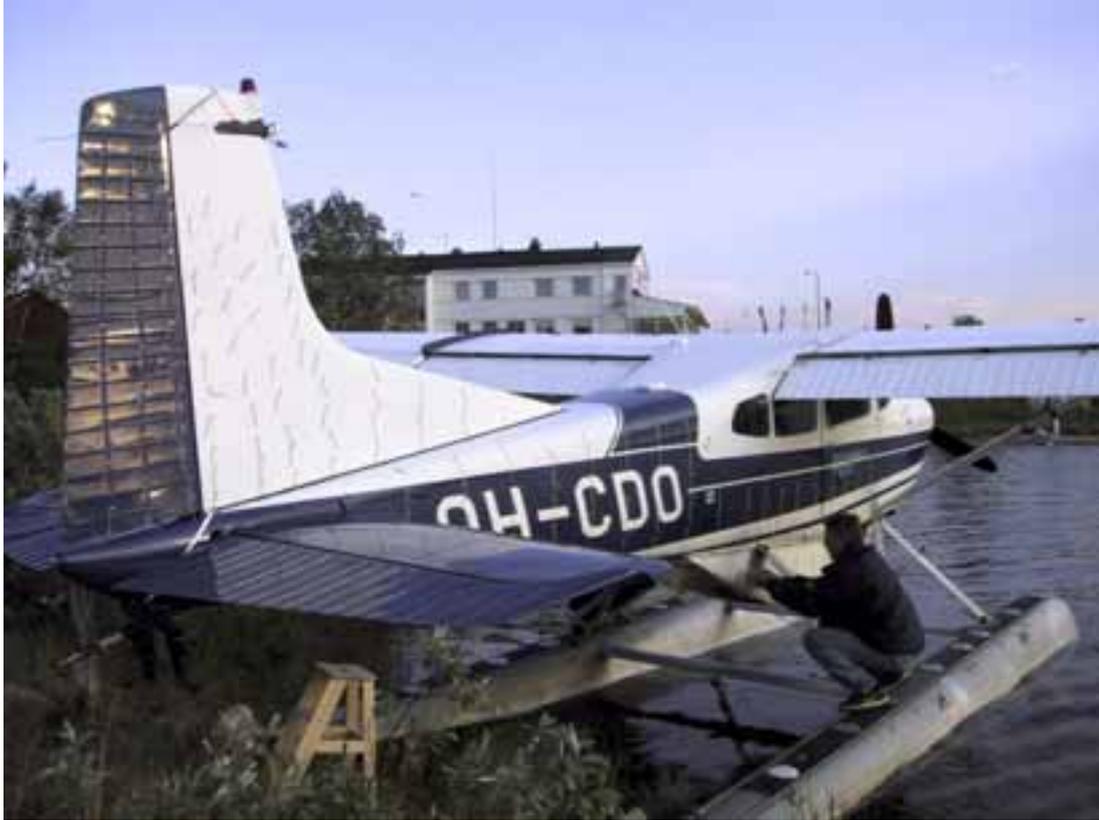
Figure 3. Aircraft fuselage, empennage and right wing upper surface were covered with wool threads for visualization. Five cameras were used to film their movement.

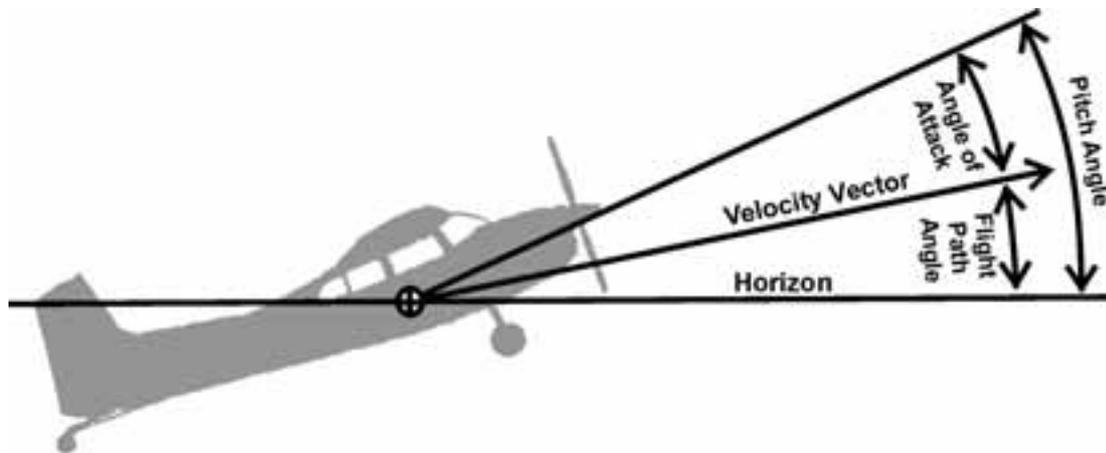
A float equipped aircraft pitch angle needs to be reduced after lift off because otherwise the pitch angle increases by itself. This is caused by two factors. First, when the friction between floats and water disappears, an unbalanced pitch up moment remains. This moment depends on the float type. Secondly, when the aircraft climbs the ground effect reduces. This causes the downwash behind the wing to increase, the horizontal stabiliser angle of attack to change and the download on the stabiliser to increase. Thus there is also a pitch up moment. Both factors pitch the aircraft nose up unless the flight path is actively controlled by the elevator. If the aircraft is let to fly “by itself” there is a risk of exceeding the stall angle of attack. The pitch angle, flight path angle and angle of attack are presented in the figure 4. It must be noted that the angles change all the time but the pitch angle is always the sum of the flight path angle and angle of attack.

Figure 4. Presentation of the pitch angle, flight path angle and angle of attack. The velocity vector coincides with the flight path angle.

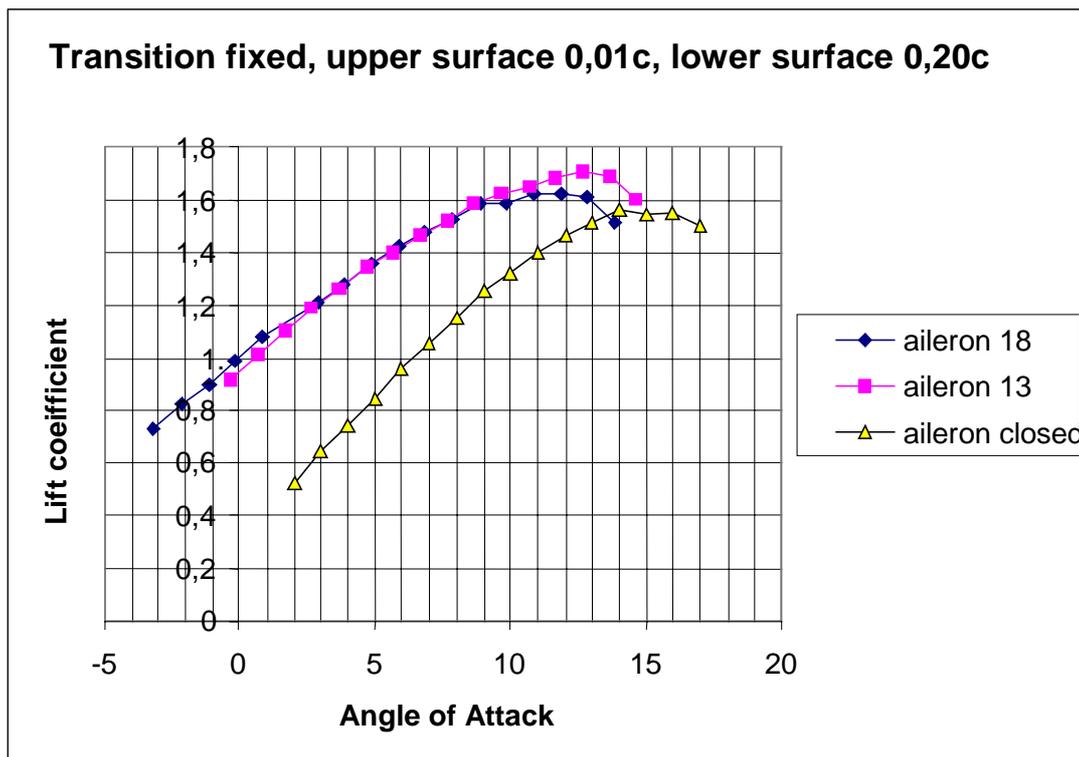
Figure 5. Lift coefficient as a function of the angle of attack with different aileron angles. Reynolds number is $3 \cdot 10^6$ and transition is fixed on the upper surface to 0.01c and on the lower surface to 0.20c.

Following conclusions can be made from the figure 5:

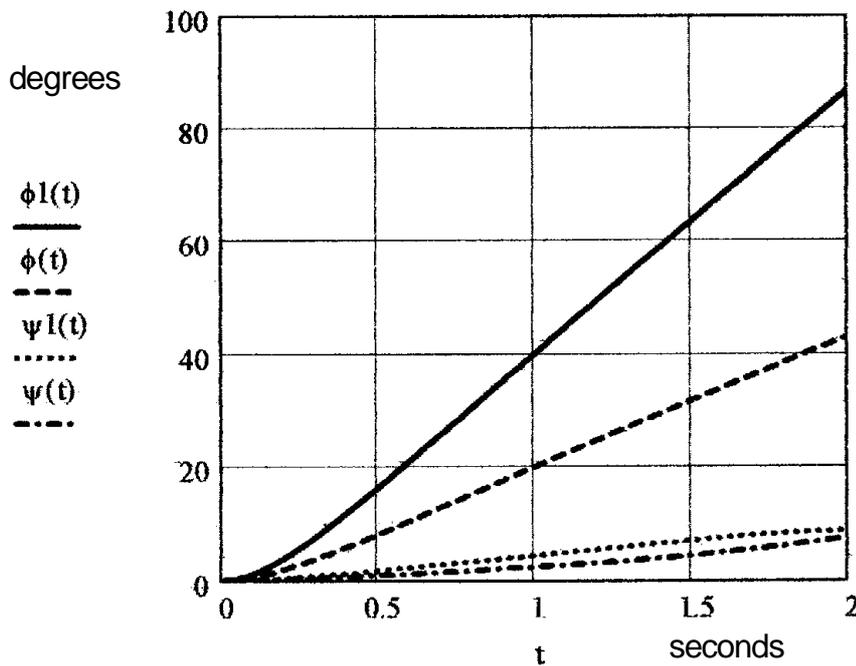
If it is assumed that the whole right wing stalls at the same time so that the lift coefficient is reduced by 0.3 or 0.6 and the drag coefficient is increased by 0.06 or 0.12, the roll rate is approximately 45 degrees in two seconds (first case, 0.3 and 0.06) and approximately 90 degrees and yaw rate 10 degrees in two second (second case, 0.6 and 0.12). It was assumed that the left wing had not stalled and vertical stabiliser was functioning normally. The assumed reductions of the lift coefficient and increases of the drag coefficient are possible for the wing. Figure 6 presents aircraft bank angle and heading in both cases. The faster movement is likely to be as fast as the accident flight.

Figure 6. Cessna 182 aircraft bank angle ϕ and heading ψ changes as a function of the time t , when the right wing lift coefficient reduces by 0.3 (0.6) and the drag coefficient increases by 0.06 (0.12) at time $t = 0$. Curves ϕ_1 and ψ_1 correspond to the values given in parenthesis. Equivalent Air Speed is 55 knots.
